# Manhole Inspection Summary

Manhole # S13S\_\_030MH

Insp Date: **4/3/08 11:36 AM**

**Location** Address: **923 Desoto Rd** Cross Street: **Wilmington Ave**

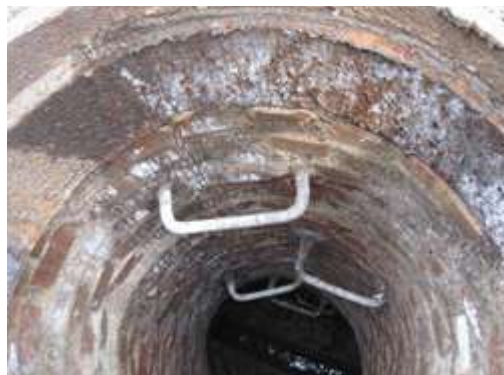
defect 3

Infiltration: ☐ None ☐ Joint ☐ Cracks ☐ Mortar ☐ Roots ☒ **Wall**

infiltration in Chimney and corbel

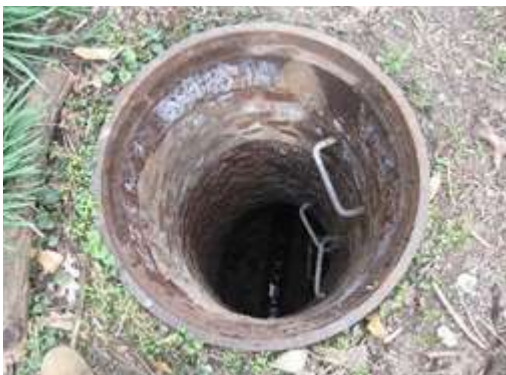
Defect 1

**Frame** Offset: **0** (in.) Condition: ☐ Sound ☐ Cracked ☒ **Leaks**

Frame leaks

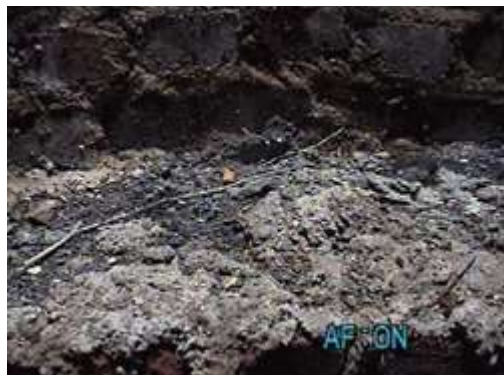
Defect 2

Condition: ☐ Sound ☐ Cracked ☐ Root Intrusion ☐ Deteriorated ☐ Leaks ☒ **Debris**

Sediment and debris on bench

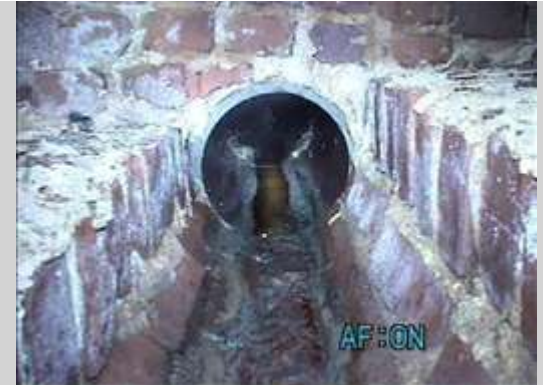
12 O'Clock Outflow

8 in. Circular Gravity Sewer  
Pipe Out @ 12 O'Clock

Pipe Height: **8.4** (in.) Rod and Bar (Angled)  
Pipe Material: **Clay** ☐ Pipe Lined  
Invert Depth: **12.90** (ft.) Flow Characteristics: **Slow**  
Deposits: ☒ None ☐ Mud ☐ Sludge ☐ Debris ☐ Grease  
Silt Depth: **0** (in.) Deposits Extent:  
Infiltration: **None** Pipe Seal Cond: **Sound**

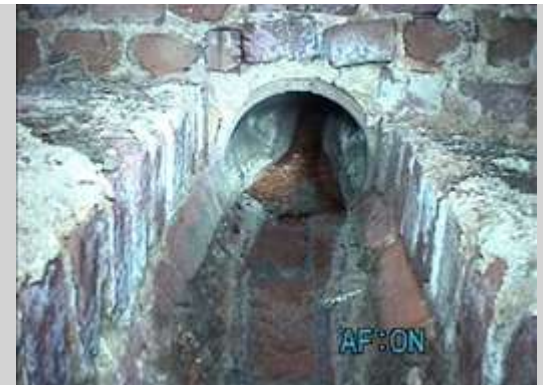
6 O'Clock Inflow

8 in. Circular Gravity Sewer  
Pipe In @ 6 O'Clock

Pipe Height: **8.4** (in.) Rod and Bar (Angled)  
Pipe Material: **Clay** ☐ Pipe Lined  
Invert Depth: **13.10** (ft.) Flow Characteristics: **Slow**  
Deposits: ☒ None ☐ Mud ☐ Sludge ☐ Debris ☐ Grease  
Silt Depth: **0** (in.) Deposits Extent:  
Infiltration: **None** Pipe Seal Cond: **Sound**
